Review of Investigation Report on the Flooding in
Sha Po Tsai Village, Tai Po on 22 July 2010

Professor Joseph Hun-wei Lee
Croucher Laboratory of Environmental Hydraulics
The University of Hong Kong

12 October 2010

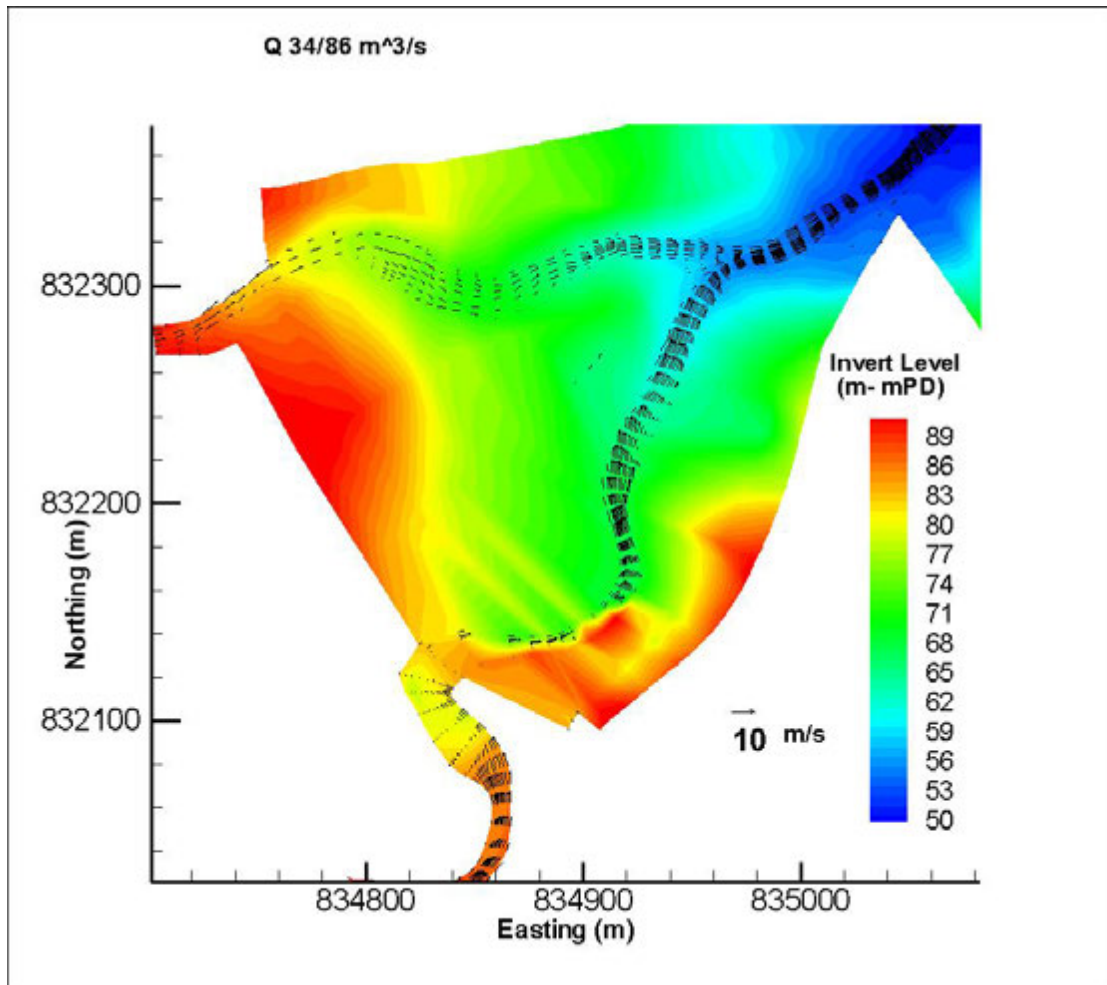
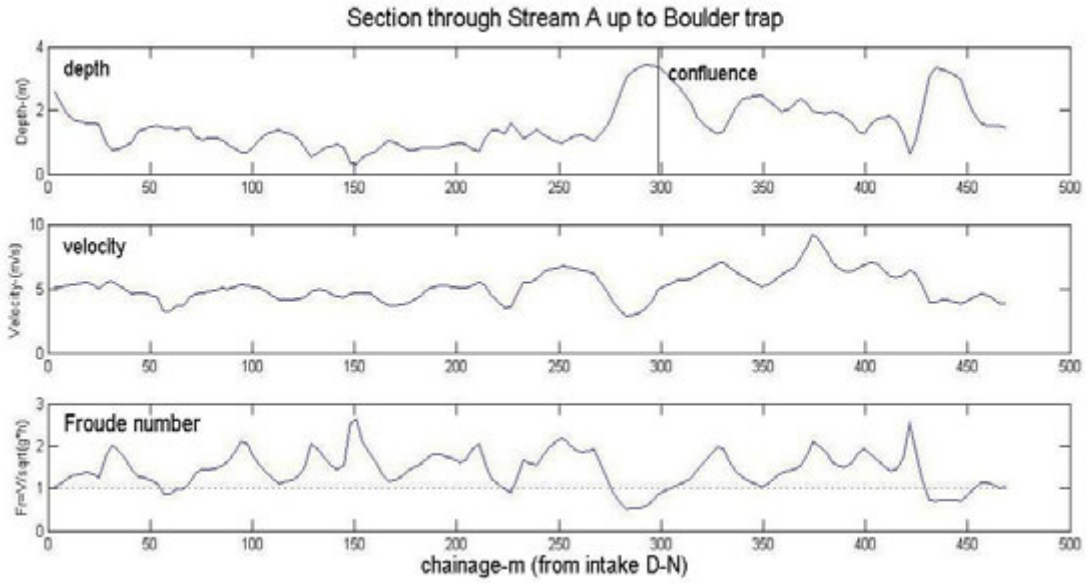
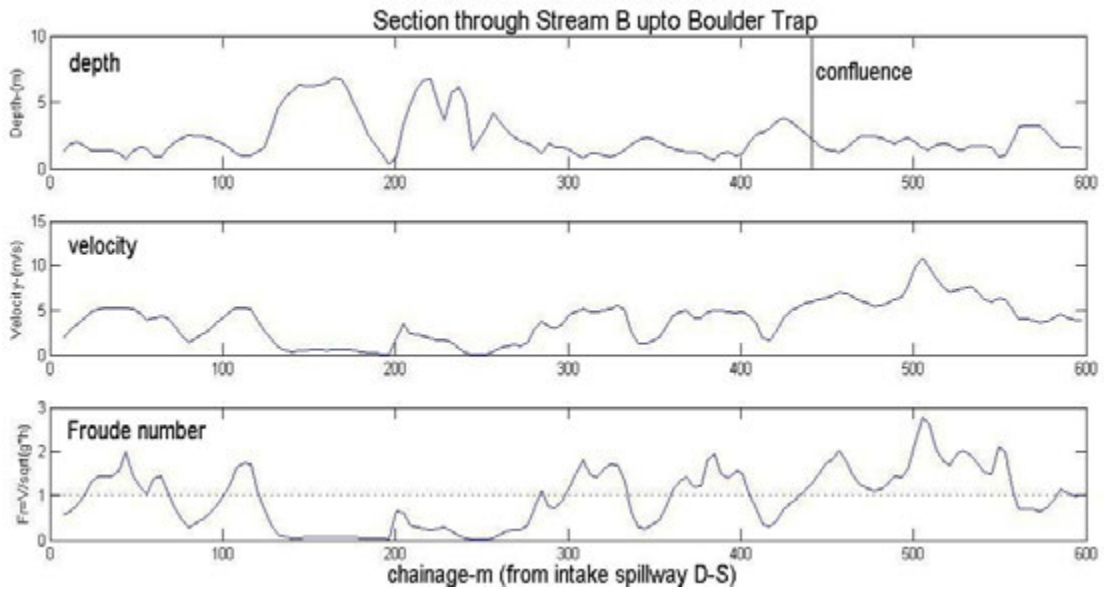
Figure B1 Velocity field at Stream A and Stream B

- The 2D hydrodynamic model results show a fast supercritical flow down the steep slopes of the two streams, with depths of around 1-1.5m, velocity of 4-6 m/s, and Froude number of Fr=1.5-2. In particular, the longer and winding Stream B induces a complex pattern of both supercritical and subcritical flows, with hydraulic jumps in between. The jumps would have resulted in significant turbulence and intense flow recirculation along Stream B. At the confluence between the two turbulent streams, the two fast moving waters collide, leading to a hydraulic jump (sudden rise in depth), and extremely high velocity (8-9 m/s) after the confluence (Appendix B).

- The pattern of computed velocities on the steep streams and after the confluence (Fig. B1-B3) is consistent with the field observations.

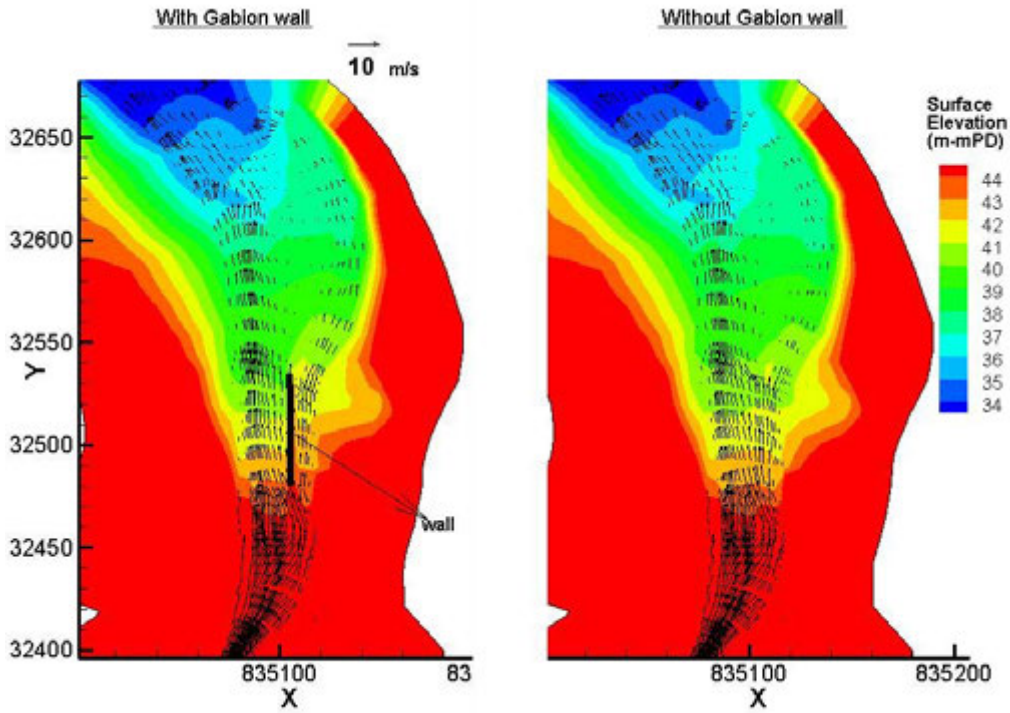
Figure B4 Predicted flow downstream of boulder trap - with and without gabion wall

- The combined flow after the confluence continues to flow as a supercritical stream with depth of about 2 m, and velocity of 5-9 m/s. The supercritical flood flow is contained within the boulder trap; there was some side spilling at the upstream right bank of the boulder trap.
- The flow immediately downstream of the boulder trap resembles a supercritical high velocity jet, with velocity of 5.5-6.5 m/s. A turbulent flow of this magnitude resulted

in significant scour of a loosely compacted bed downstream of the boulder trap (Fig.B4).

The 60 m long gabion wall downstream of the boulder trap did not affect the flow through the east branch which seems to be chiefly governed by the topography and flow capacity (Fig.B4 and Fig.C1, C2).

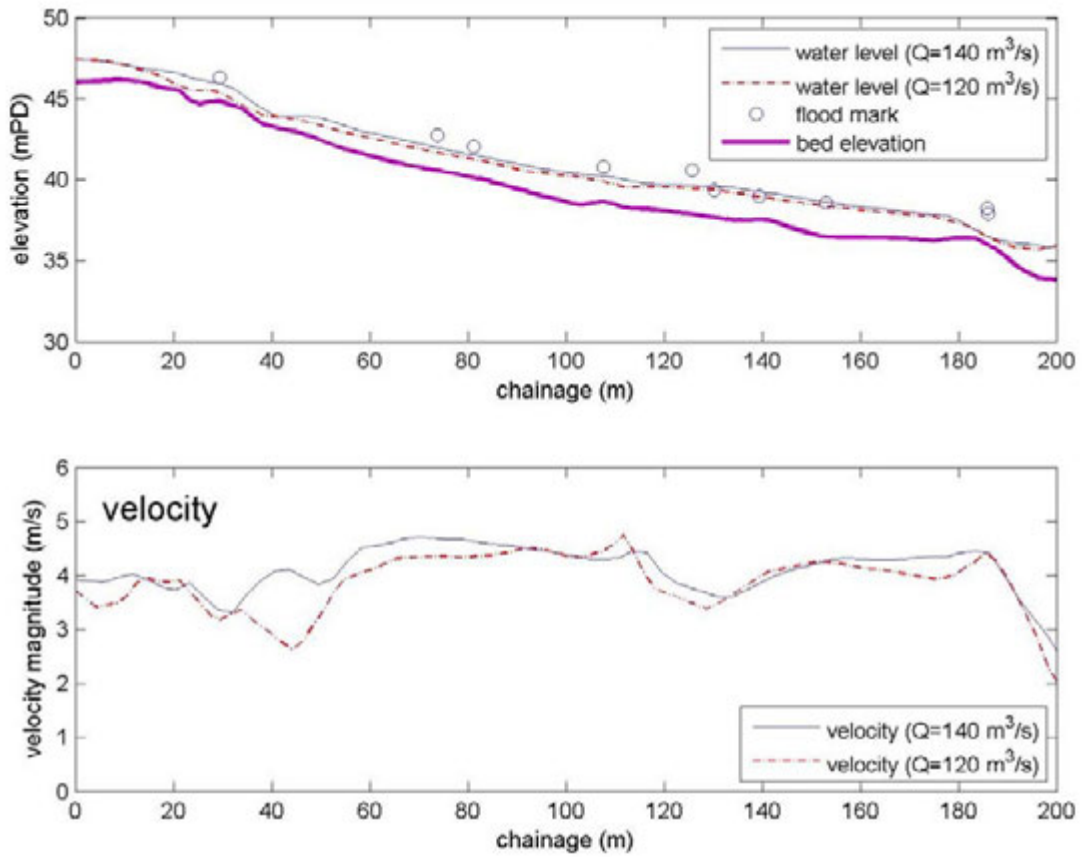
Figure B5 Predicted water surface elevation along central branch CH_C 0-200

- The velocity field shows most of the flow going into the central branch; significant velocities behind the gabion wall are predicted. It also shows relatively little flow going into the east branch with a higher bed elevation - around 20 m³/s.
- The velocity field without the gabion wall shows little difference. The flow split into the east branch is also relatively insensitive to the presence of the gabion wall.
- In general, the flow depth leading up to about CH_C 200 (upstream of Sha Po Tsai) is not large, about 1-2 m, with a velocity of around 4 m/s (Fig.B5).

- In summary, the high velocity flows in both the west and central branches are capable of transporting coarse sediment and extremely hazardous.
- Overall, the predicted water surface levels correlate well with the field observations (Fig.B5 and B9).

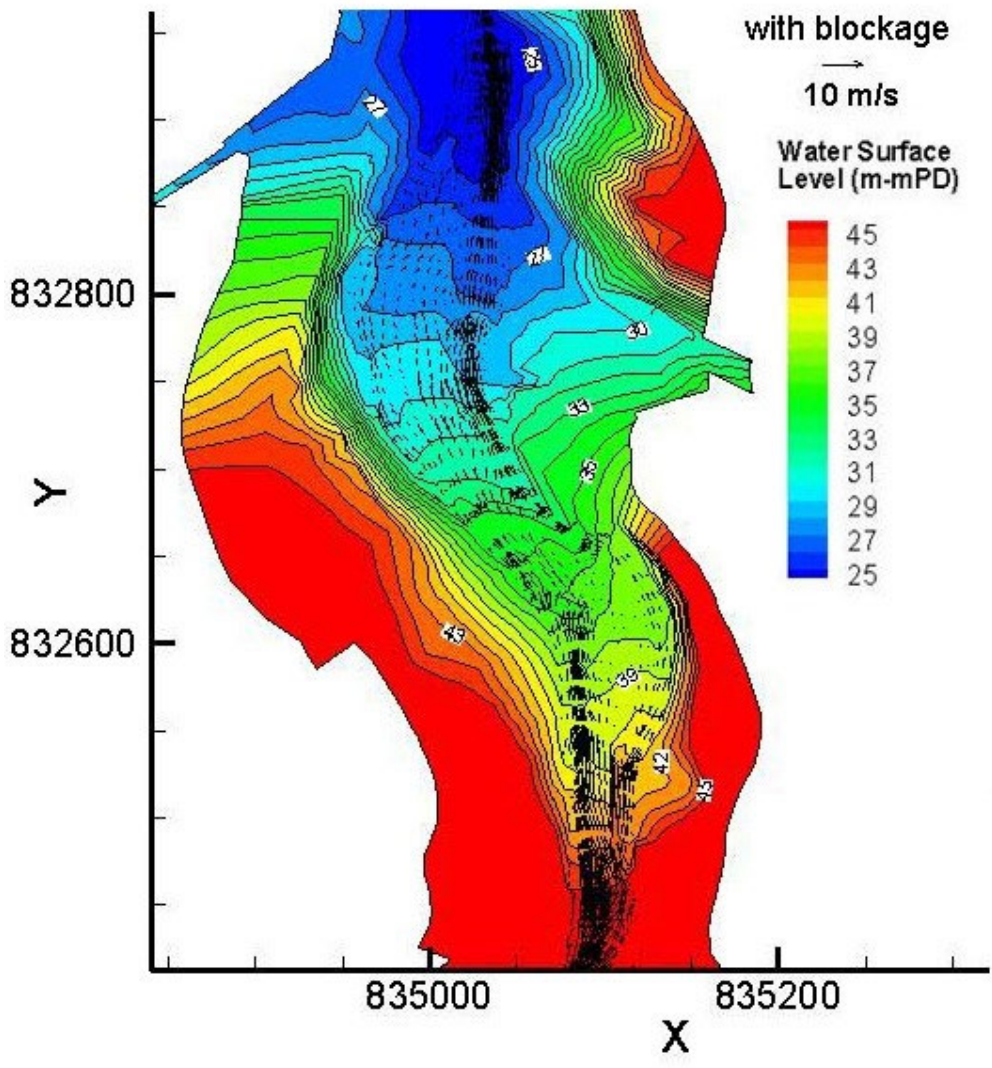
Figure B6 Predicted flow field from boulder trap to Sha Po Tsai Village

- The computed flow shows that the flow first splits into the central and east branches. As the flow approaches the village and the check dam area, part of the stream flows into the west branch. The east branch also rejoins the central branch near the check dam (Fig.B6).

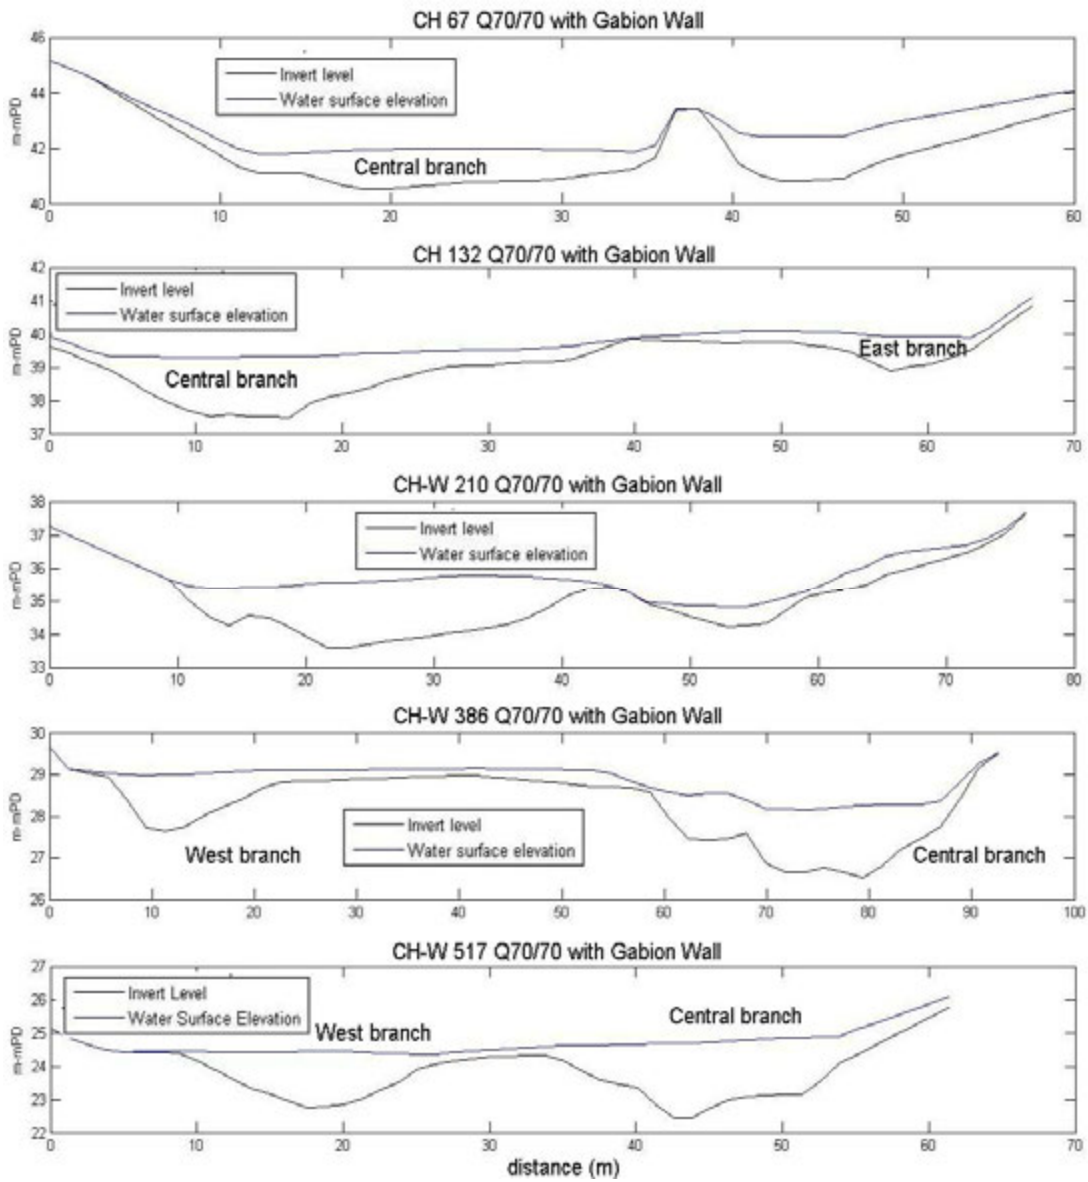
Figure B7 Predicted transverse water surface profile at different cross-sections

- There is relatively little flow into the east branch with the higher bed elevation (Fig.B7).
- There is clear pile up of the water in front of the flood wall next to the check dam, with overflow into the west branch and also into the central branch above the fully blocked bridge crossing (see Appendix C).

- Flood levels of over 36 mPD are predicted at the check dam; when combined with a raised river bed (by 1-2 m due to coarse sediment), the flood levels can be even higher, approaching 38 mPD (Fig.B7).

- The flood level and bed level of the west branch is higher than those of the central branch; the flow along the west branch is complicated, with depths of 2.5-3 m, and velocity of 3-4 m/s (Fig.B7 and Fig.B8).

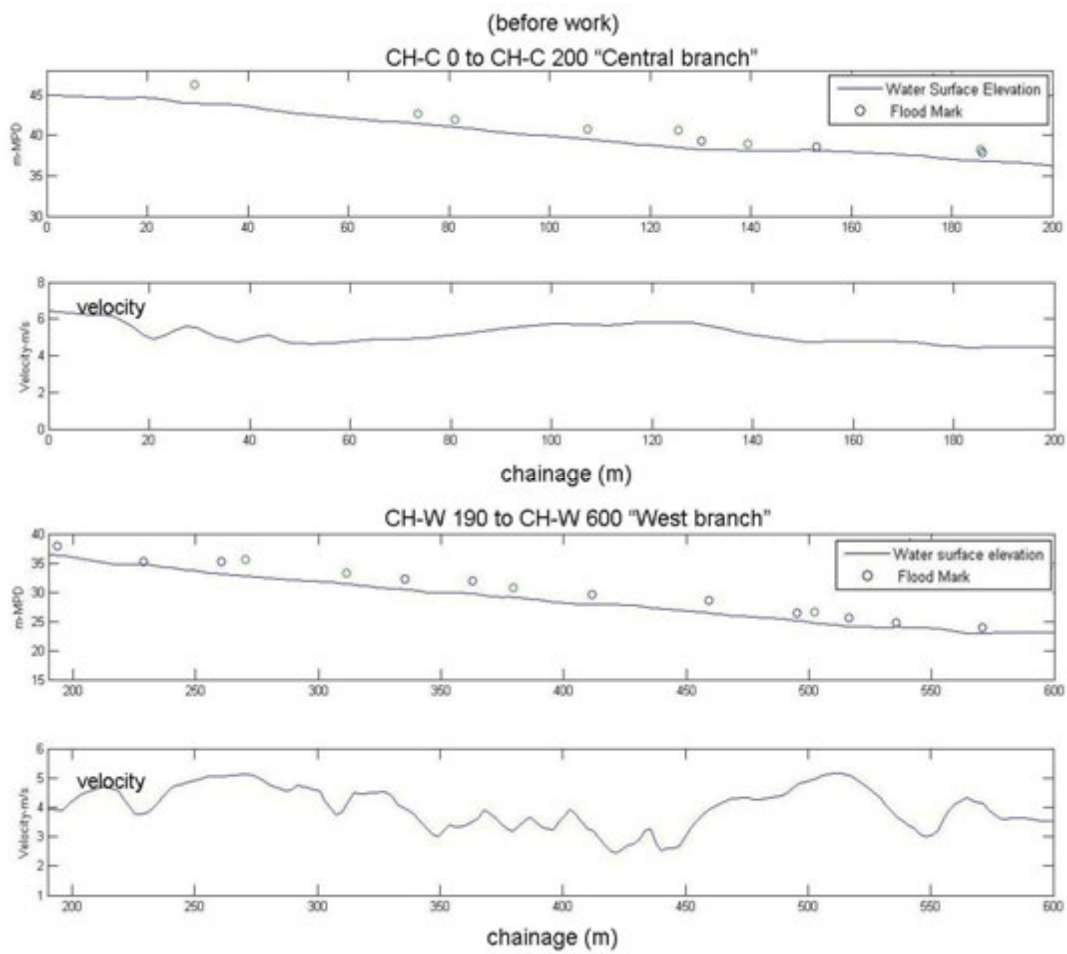
Figure B10 Predicted water surface elevation along central and west branches (pre-project)

- In the absence of all engineering works, both 2D and 3D model calculations show that flooding would still have occurred (Fig.B10, see also Appendix C).

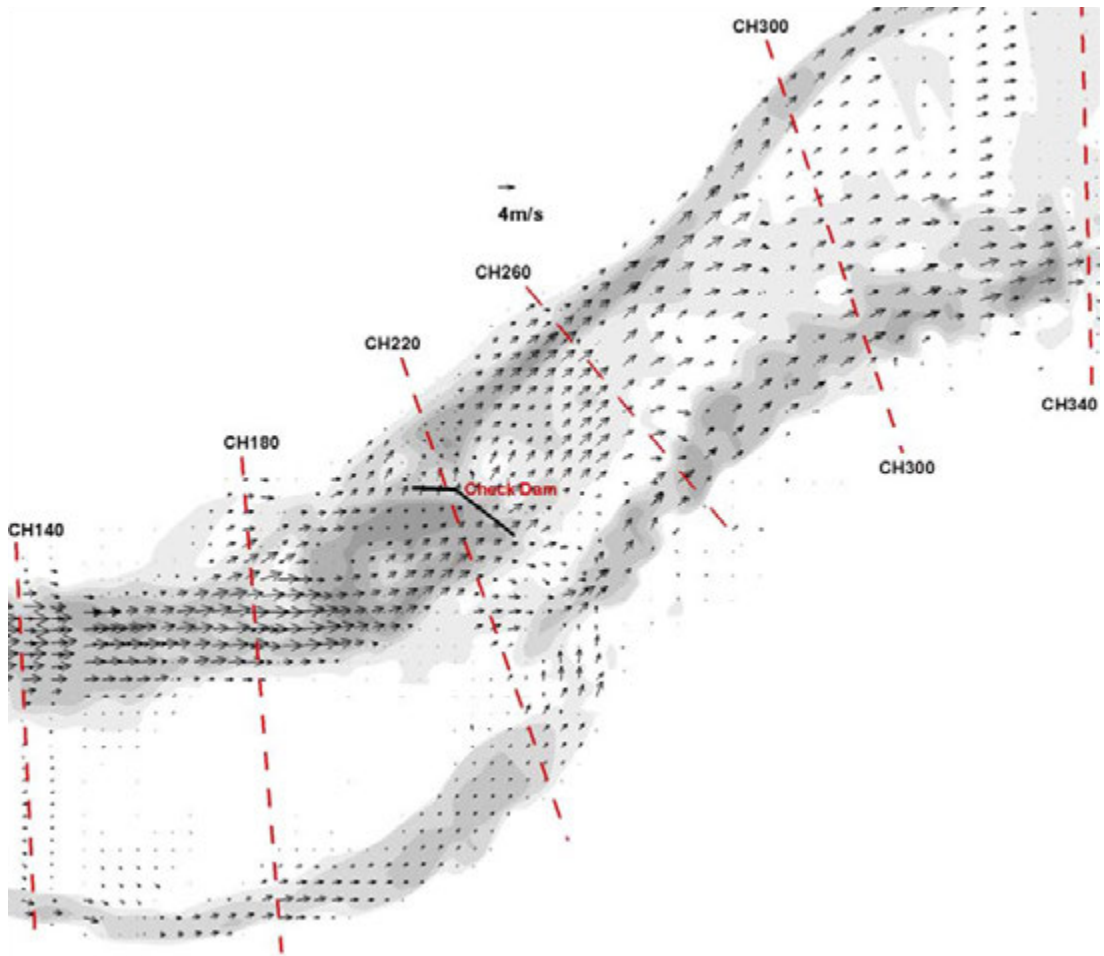
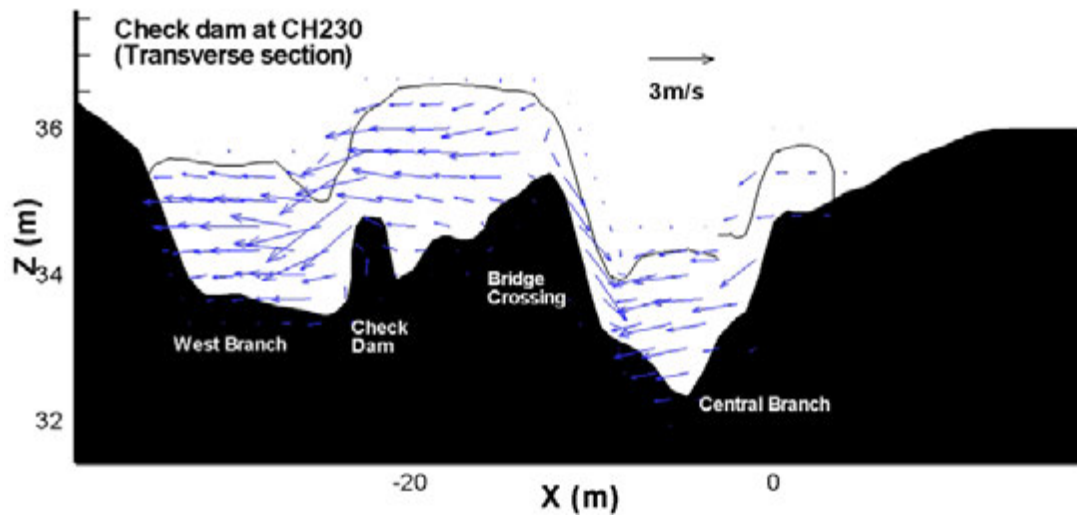
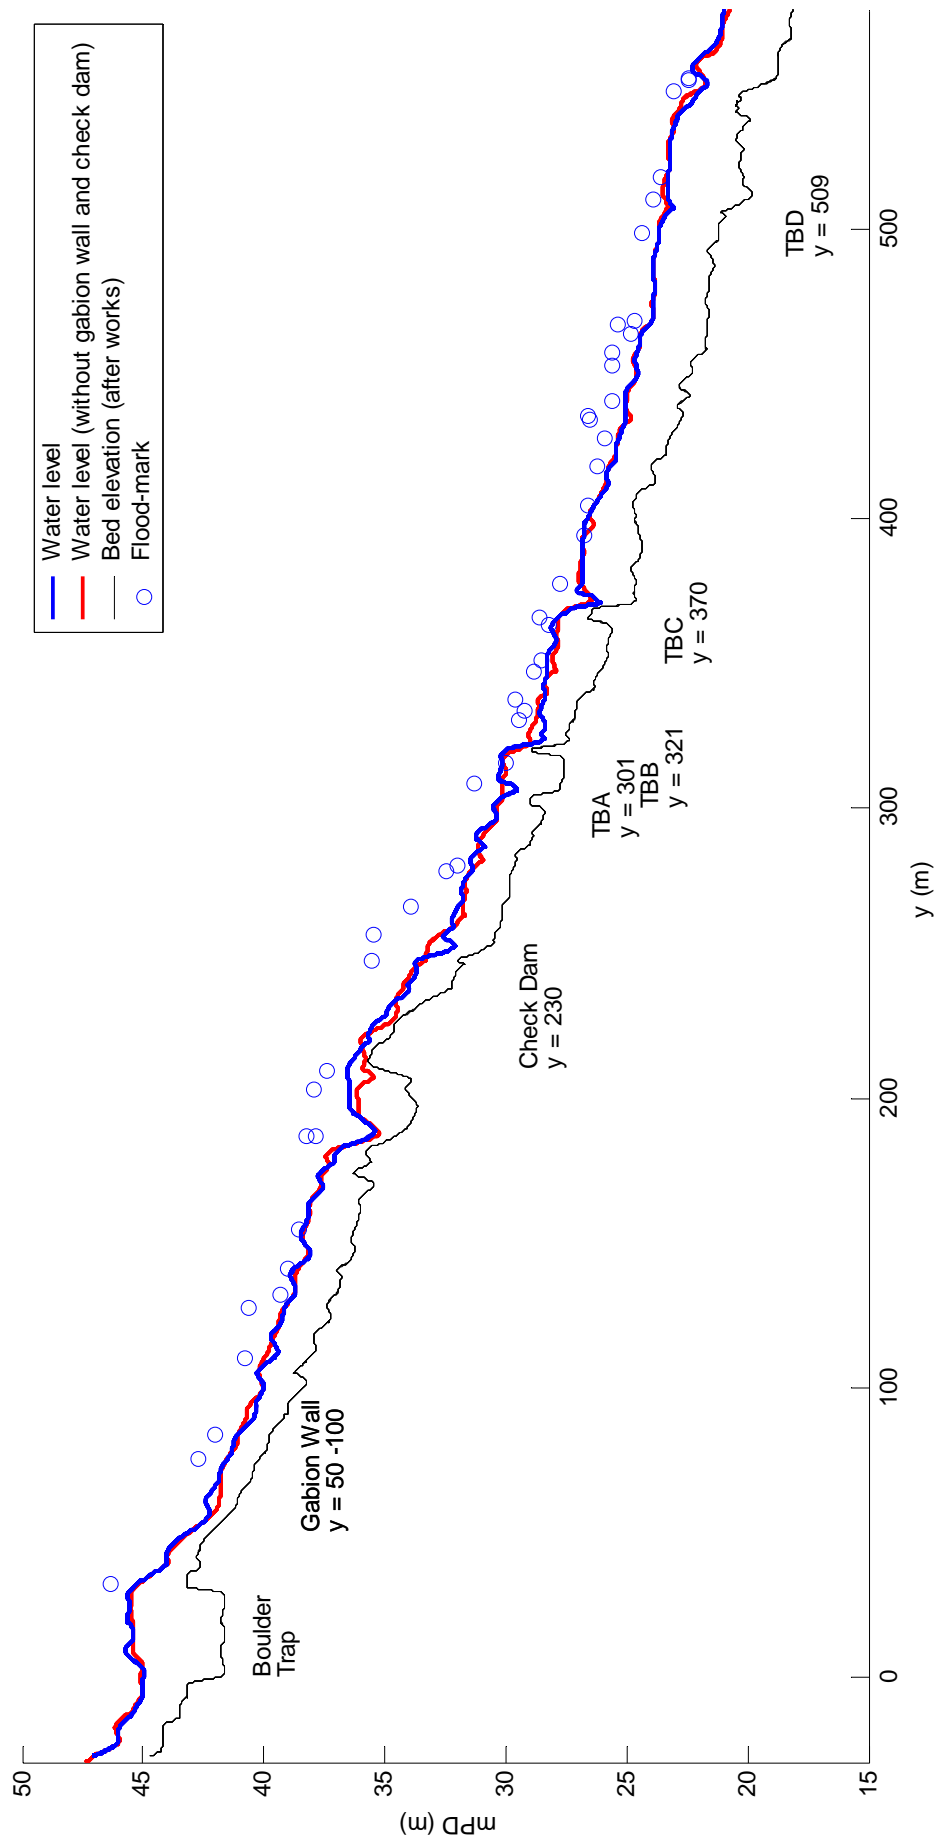
The presence of the check dam and gabion wall near CH230 did not aggravate the flooding situation in terms of maximum flood level and velocity in the Sha Po Tsai vicinity. The flood flow impinging on the pre-existing flood wall and the head of the island would result

in a pile up of water and subsequent flooding; this would be further aggravated by any coarse sediment that would block the bridge crossings to some extent (Fig.C3, C4 and C5).

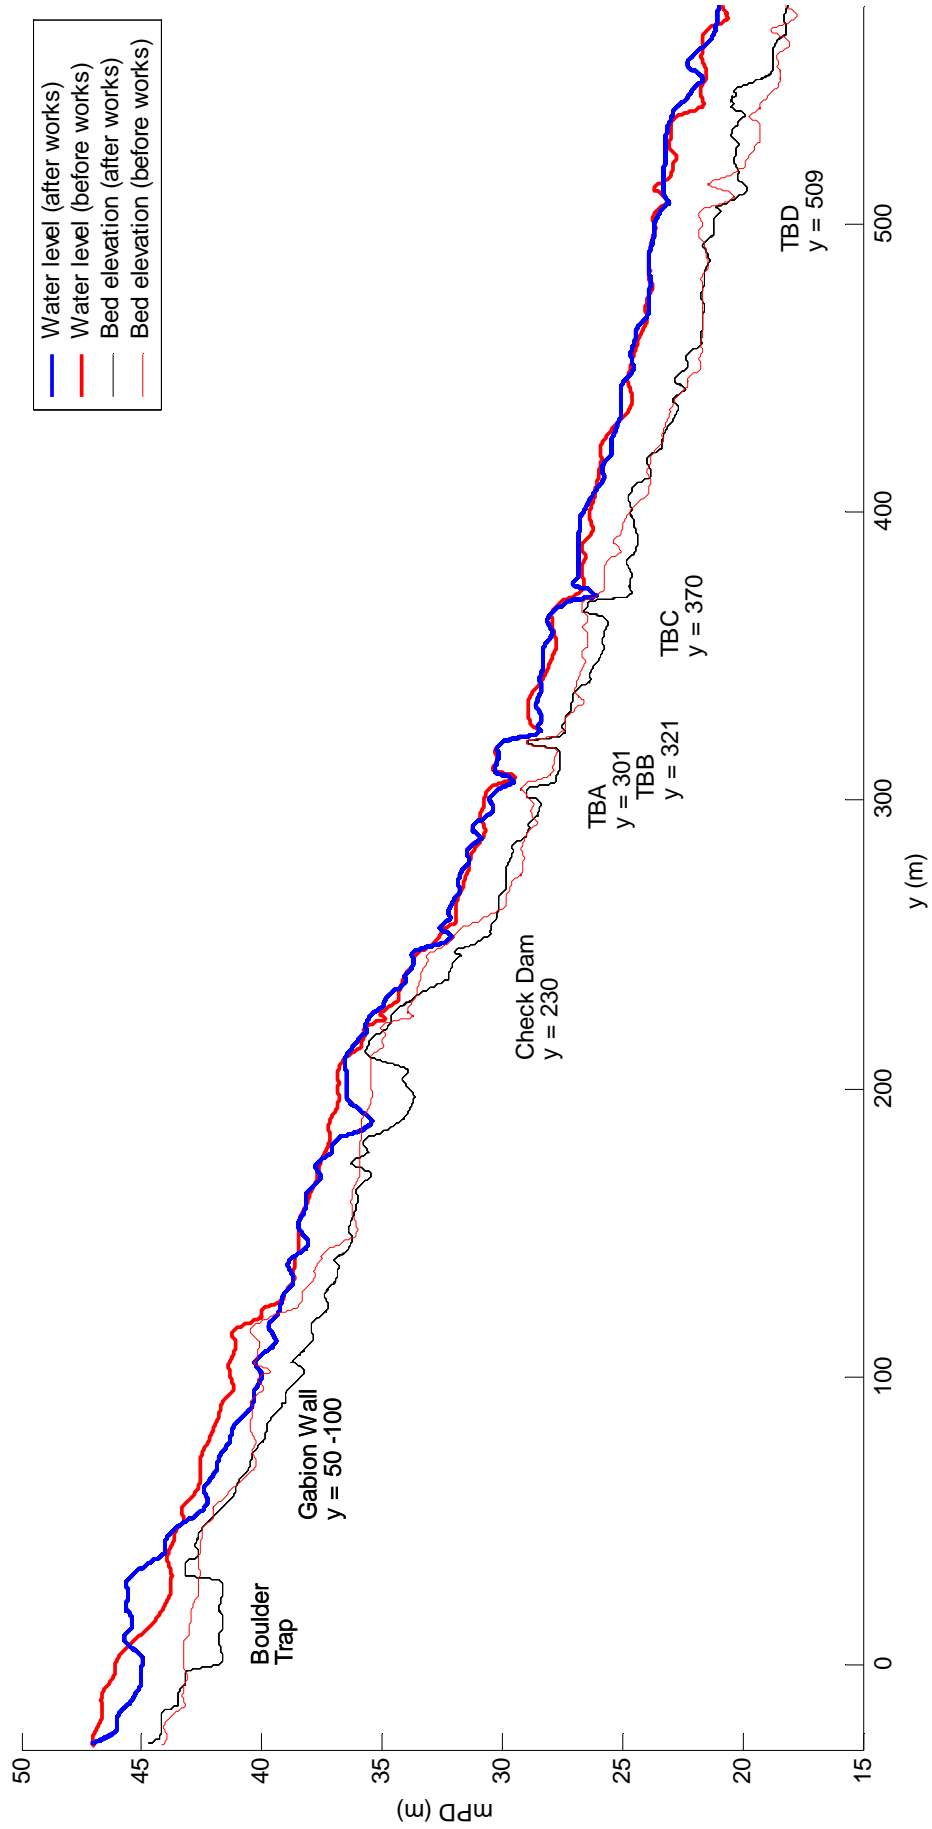
Fig.C6 Predicted water level along main (central) branch of Tai Po River

The results show that even in its natural state, the Tai Po River would have flooded to similar levels when subjected to this flood flow (Fig.C6). Compared to the pre-project situation, the completed works have resulted in some minor decrease in flood level and velocity in some locations but increase in other locations. Overall, it is judged that the difference in flood risk due to the constructed works is acceptable.
